**SMITH-EMERY LABORATORIES**

Proj./Job No.: 43208-1  
Lab. No.: L-15-1916b

Subject: **23-1/2" x 23-1/2" x 1-1/2" Wood Tiles**  
Test Method: **Uniform Load Test on IPE Wood Tiles**  
Specification : CISCA, Recommended Test Procedures for Access Floor, 2007  
Source : Submitted to Laboratory by Client.

Report of Tests

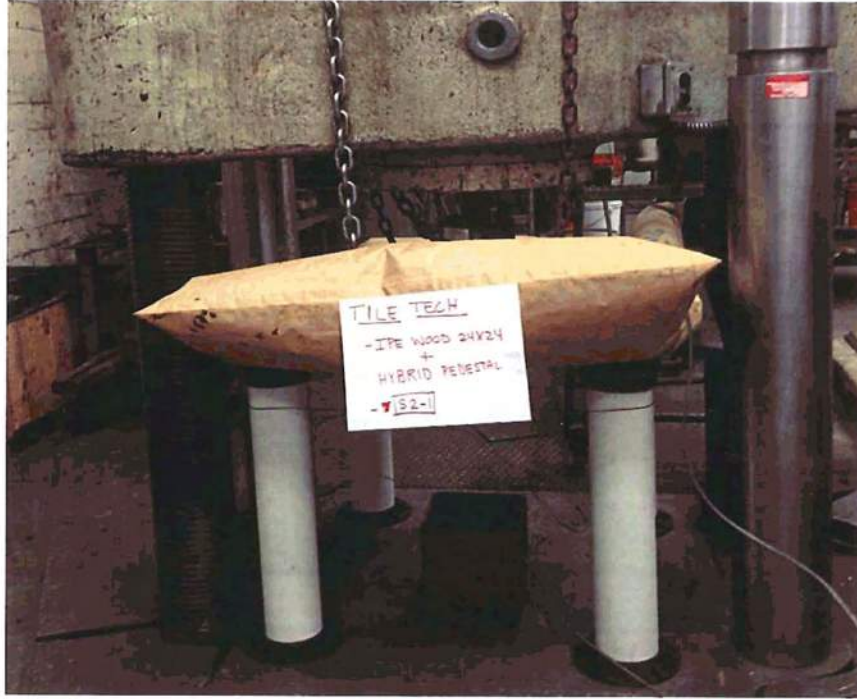
Photo No.1 General Test Setup

Each sample was conditioned and placed according to client instructions on approx. 24 inches height pedestals located at each of the four sample corners. The testing machine was a Baldwin UTM with 440 Kip load capacity. Load was applied through a 24-in by 24-in by 3/4-in plate underplayed by an air-bag to equally distribute the force at a rate ranged from 50 to 150 lbs. per second until failure. Photos and graphs are included in pages 2 and 3. Results are as follows:

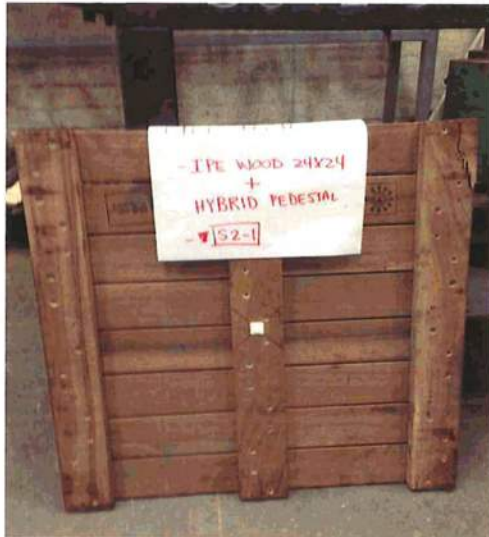
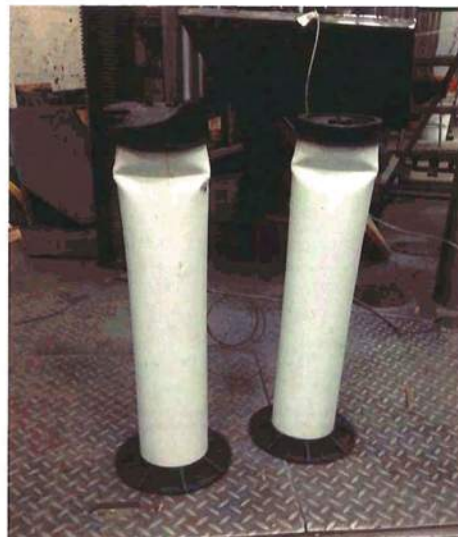
Photo No.2 Typical Failed Sample

Sample No.	Load at 0.067-in deflection, lbs.	Maximum Load, lbs.	Maximum Deflection, in.	Remarks
S2-1	280	15,040	1.44	Two Pedestal failed at max load.
S2-2	157	15,528	1.60	Two Pedestal failed at max load.
S2-3	238	15,213	1.44	Two Pedestal failed at max load.
<b>Average:</b>	<b>225</b>	<b>15,260</b>	<b>1.49</b>
